Erosion and Sedimentation Control Recommendations Unnamed 3, Larimer County, Colorado

February 7, 2013

U.S. DEPARTMENT OF AGRICULTURE NATURAL RESOURCES CONSERVATION SERVICE UNNAMED THREE FLOOD PROTECTION RECOMMENDATIONS

COVER SHEET
UNNAMED THREE FLOOD PROTECTION RECOMMENDATIONS
HIGH PARK BURN AREA
JOB CLASS _____
LARIMER COUNTY

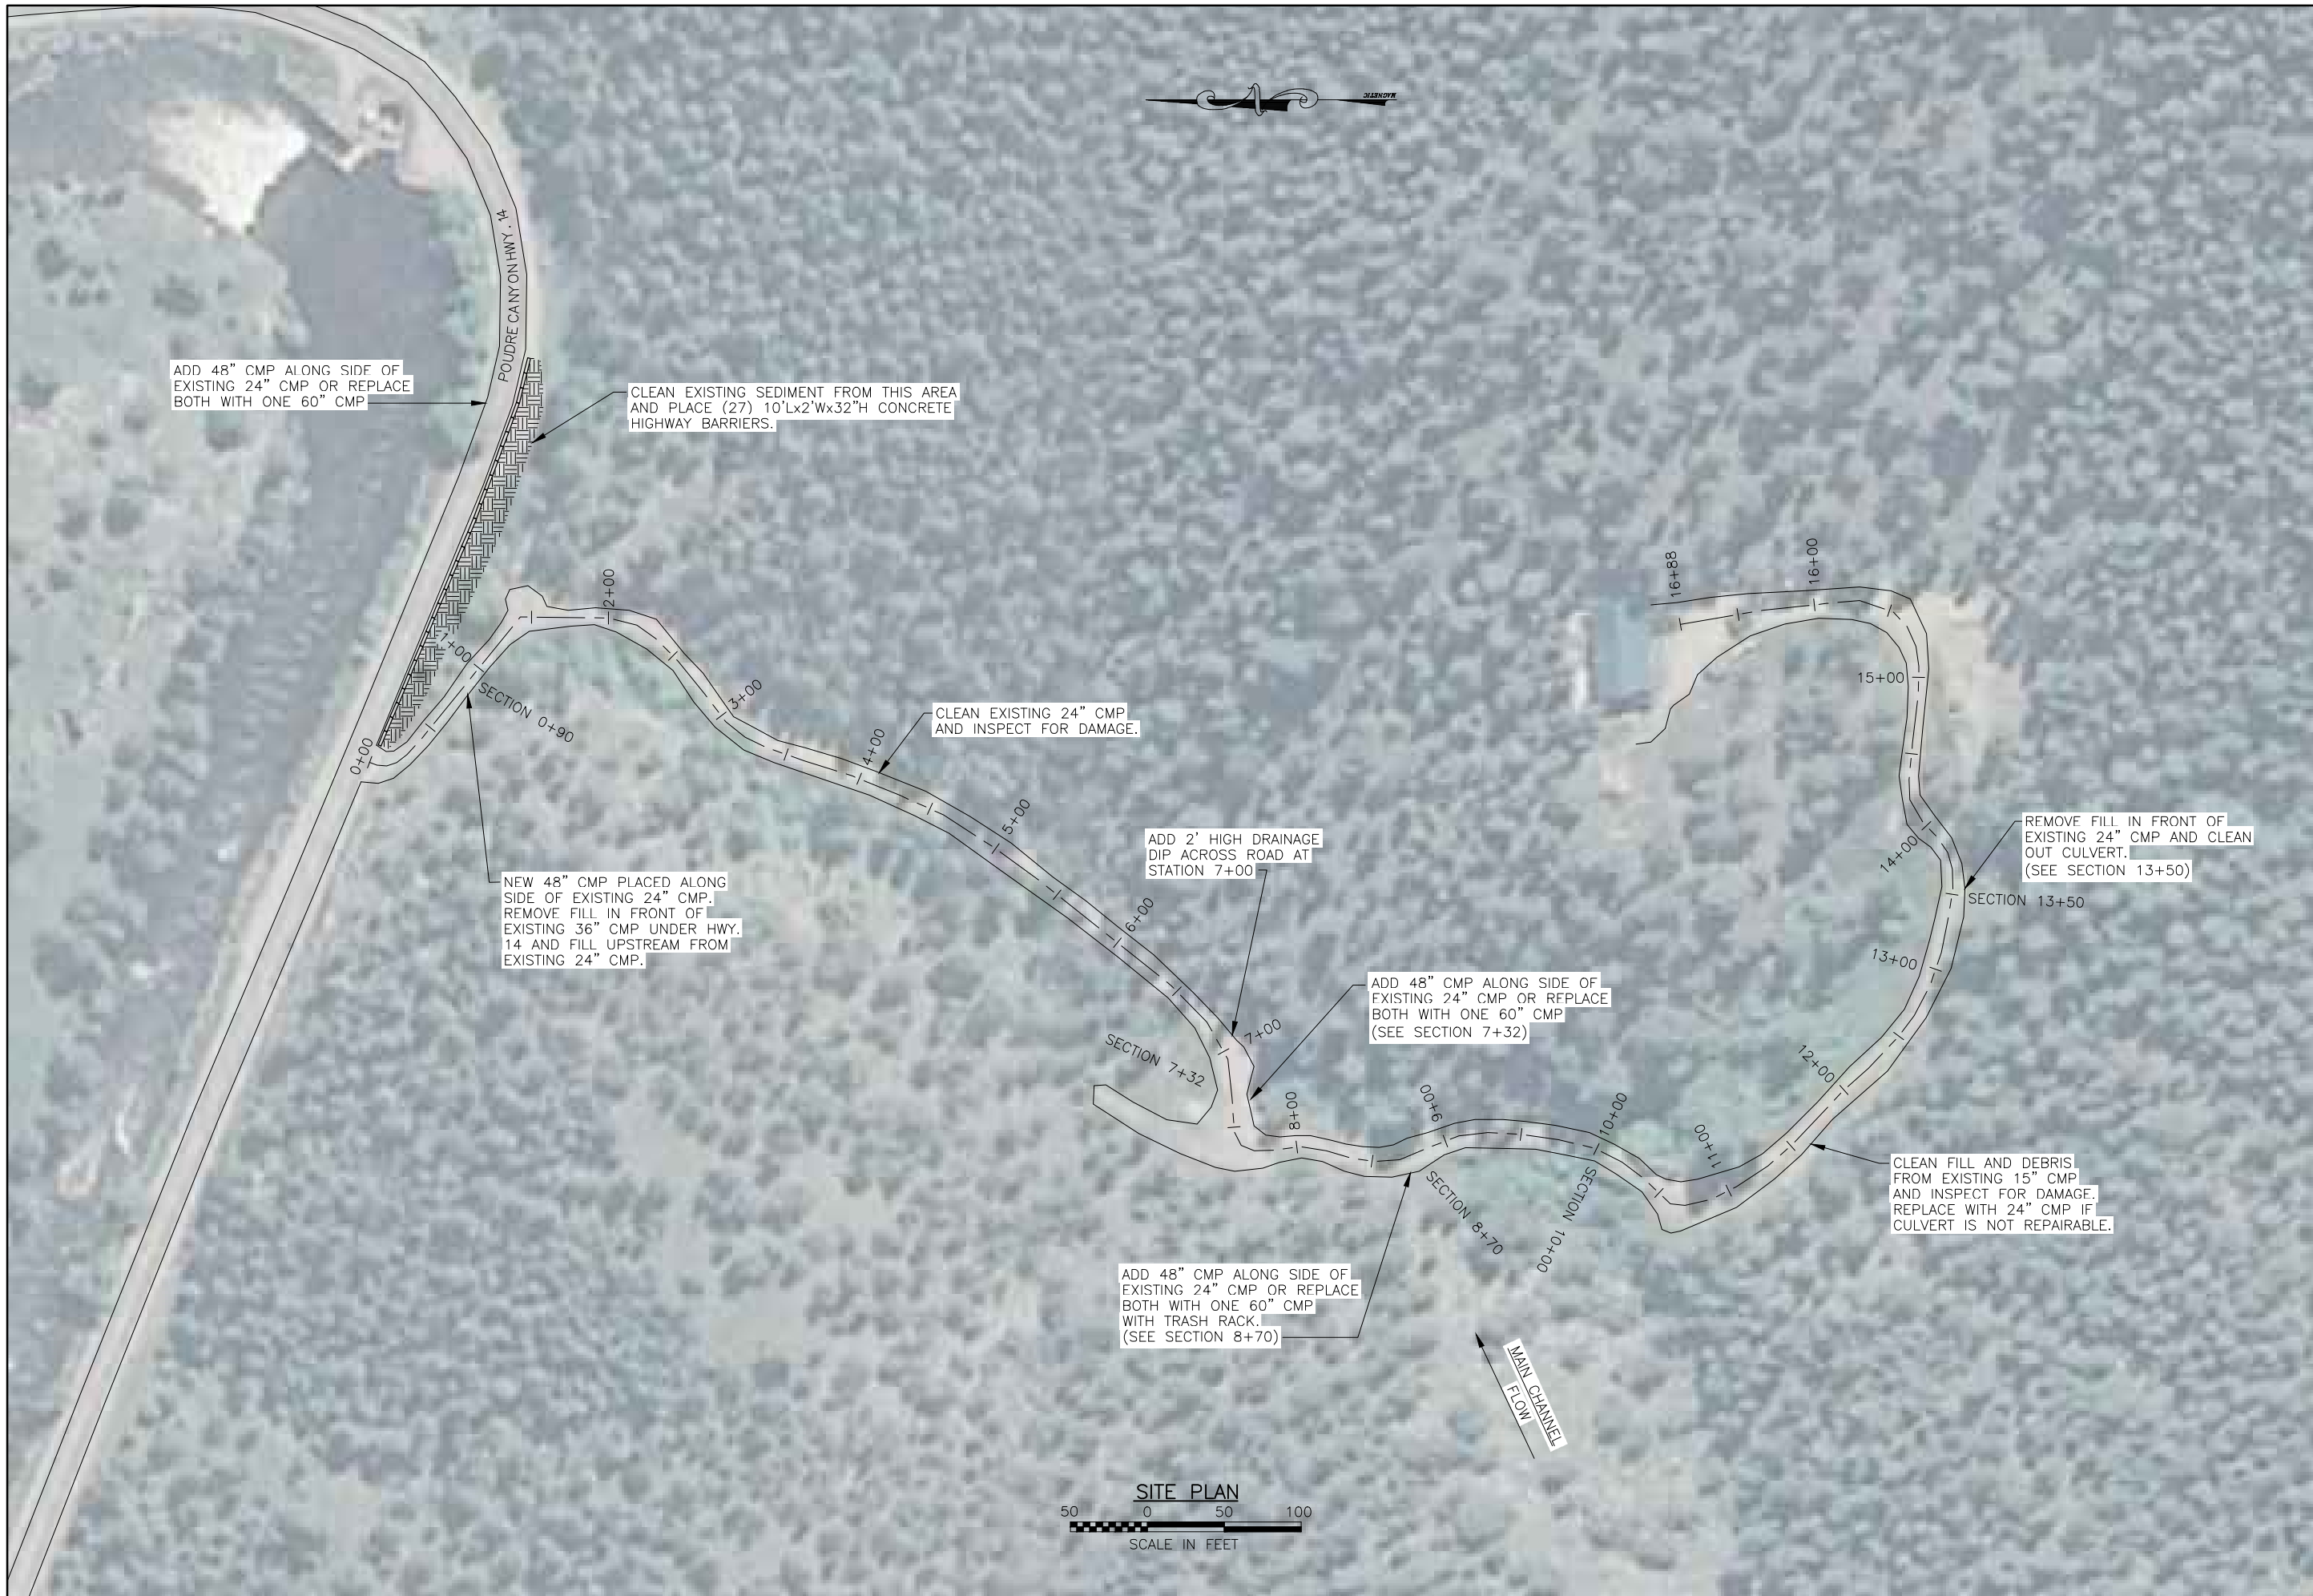
SITE PLAN

The driveway in the Unnamed 3 drainage serves as the only access for a single residence. The driveway crosses the main branch of the drainage 3 times and is very steep, with a slope gradient between 15 and 20 percent over a majority of its length. Each of these crossings has a 24-inch cnp culvert. The lower 2 culverts plugged or partially plugged during the July, 2012 flood event. The driveway also intercepts several minor tributaries as well as flow from the steep slopes above the driveway.

The accumulation of sediment upstream of the culverts along the driveway, along the side of the highway, and in the river gave very clear indications of the nature and magnitude of the problem. The very steep driveway had been reconstructed following the flood event earlier in the summer. Little attention was given to the development of roadside ditches or clearing of culverts during the reconstruction. The reconstructed driveway is sloped toward the mountainside in many places presumably as a safety measure for winter driving. As a result, water on the road will be directed toward the up slope side of the driveway. The culverts placed to conduct water from roadside ditches into the main drainage are inadequate for post fire conditions and they are susceptible to being plugged by sediment during a high flow event. There are few water bars on the driveway.

The principal problem at this site is the very substantial potential for high flows to produce large volumes of sediment at the mouth of the drainage. This is due in large part to the limited capacity of the existing driveway culverts on the main branch. In addition, the roadside ditches and smaller culverts draining the several minor tributaries intercepted by the driveway are not adequately developed, sized, and/or maintained to convey the estimated flows from a significant precipitation event under post fire conditions. Flows beyond the capacity of culverts or roadside ditches are forced onto the driveway. If the culverts become plugged, all the flow is forced onto the driveway. Water flowing down the steep driveway rapidly erodes the surface and roadbed material ultimately producing a large volume of sediment which is deposited at the bottom of the slope, on the highway and in the Poudre as happened in July, 2012. During that event, flow overtopped the driveway at the lowest crossing, at the driveway gate. The flow split at this crossing with the majority of the flow crossing the driveway and flowing onto the highway and into the Poudre. The other flow path followed the driveway to its intersection with the highway producing a second lobe of sediment.

Removing the accumulated sediment in two small natural basins created by the driveway crossings would provide for a small volume of sediment storage in the future and prevent the sediment currently in those basins from being remobilized and deposited on the highway or in the river. The lower basin is very small, extending about 50 feet upstream of the first crossing, at the driveway gate. The second basin is at the second crossing and is about 70 feet long and 25 feet wide and perhaps an average of 2 feet deep. These are relatively small, easily accomplished items of work especially if they are combined with other larger scale work items.

Reducing the amount of sediment deposited on the highway and in the Poudre can be accomplished with a sediment basin. Placing 32-inch high highway barriers from the boulders below the mouth of the drainage eastward for 200 feet along the shoulder of the highway would create a basin with potential sediment storage volume of more than 800 cubic yards.

Installing a 36-inch culvert along with the existing 24-inch culvert in the main branch driveway crossings would improve the capacity to about 80 cfs. Installing a 48-inch culvert with the 24-inch culvert increases the capacity to about 110 cfs. This is still significantly less than the estimated 200 cfs flow produced by the 25 year-1 hour storm event. Alternatively, the existing culverts could be replaced by a cattle guard type structure consisting of an open concrete channel about 8 feet across and 3 feet deep with a removable grill over the top. The bottom of a structure could be constructed on a grade that would ensure that sediment would be carried through the structure. This type of structure would be easily inspected and easily cleared of debris by removing the grill. Two structures of this type would be needed, at the first and second crossings.

Realignment of the driveway between the second and third crossings, keeping the driveway on the east side of the drainage would eliminate much of the potential for flood waters to reach the

In order to avoid splitting the flow at the first crossing and having two flood flows cross the highway, the crossing must be modified to ensure that the entirety of the flow is directed straight across the driveway and over the bank.
